Survey report m/y "La Calypso"

Bibione – Porto Baseleghe 16/07/2024

Builder Ancora Yachts – Model 44

Registration number 921774 UK

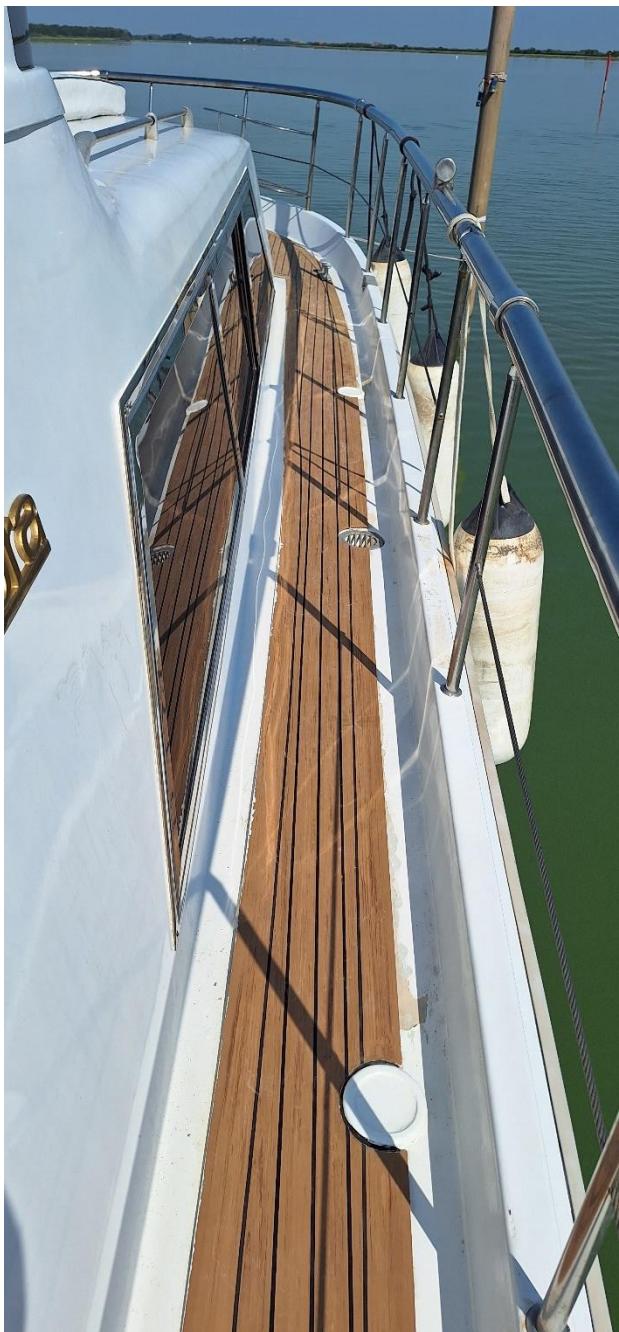
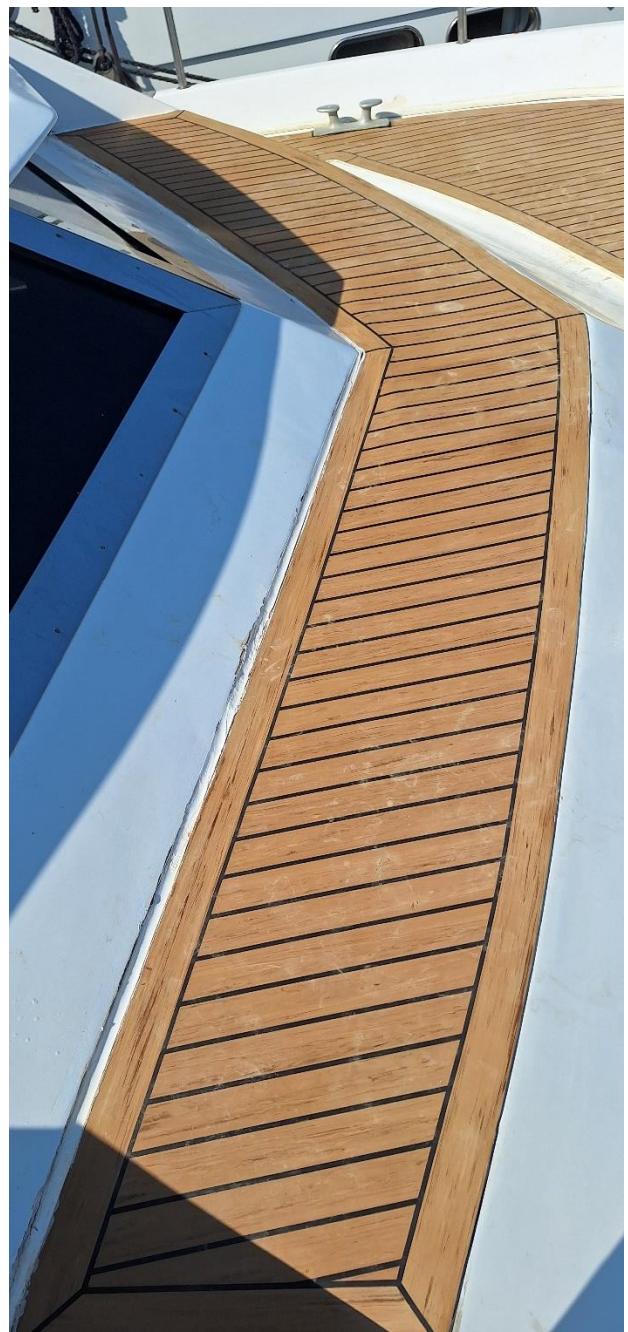
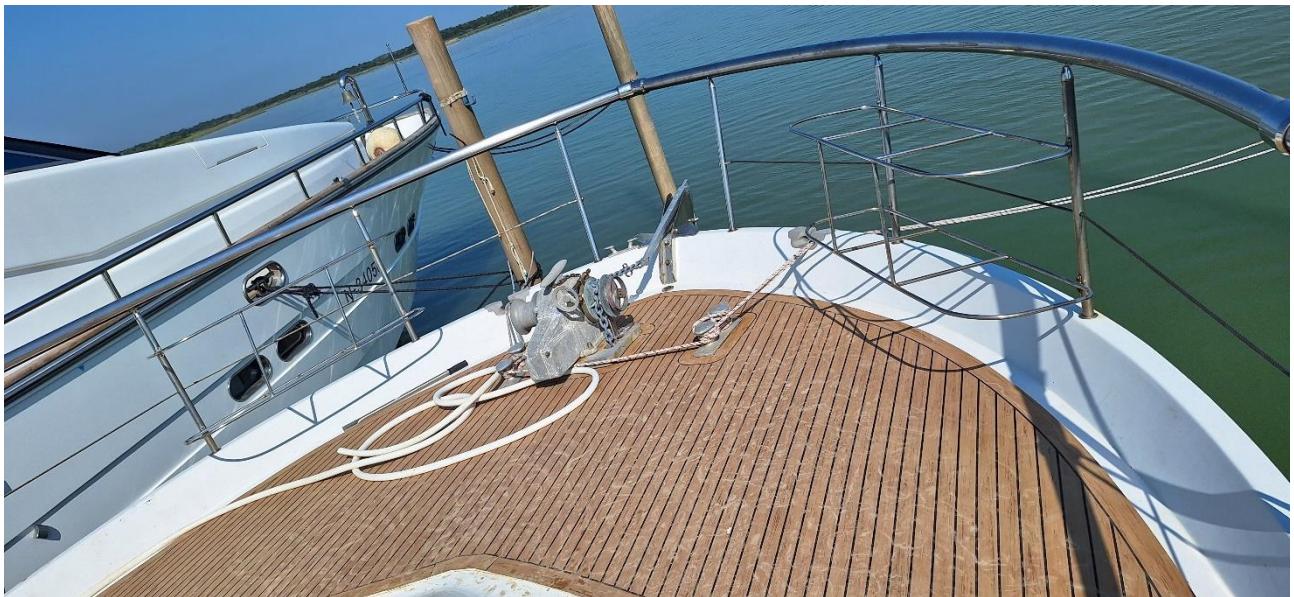
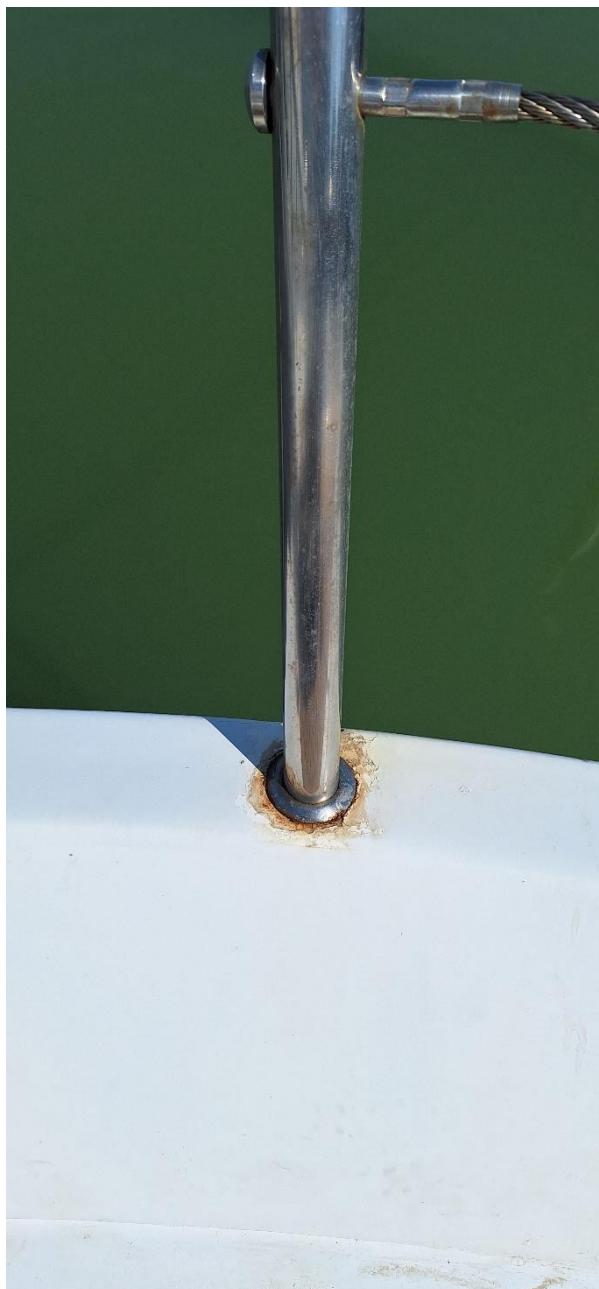
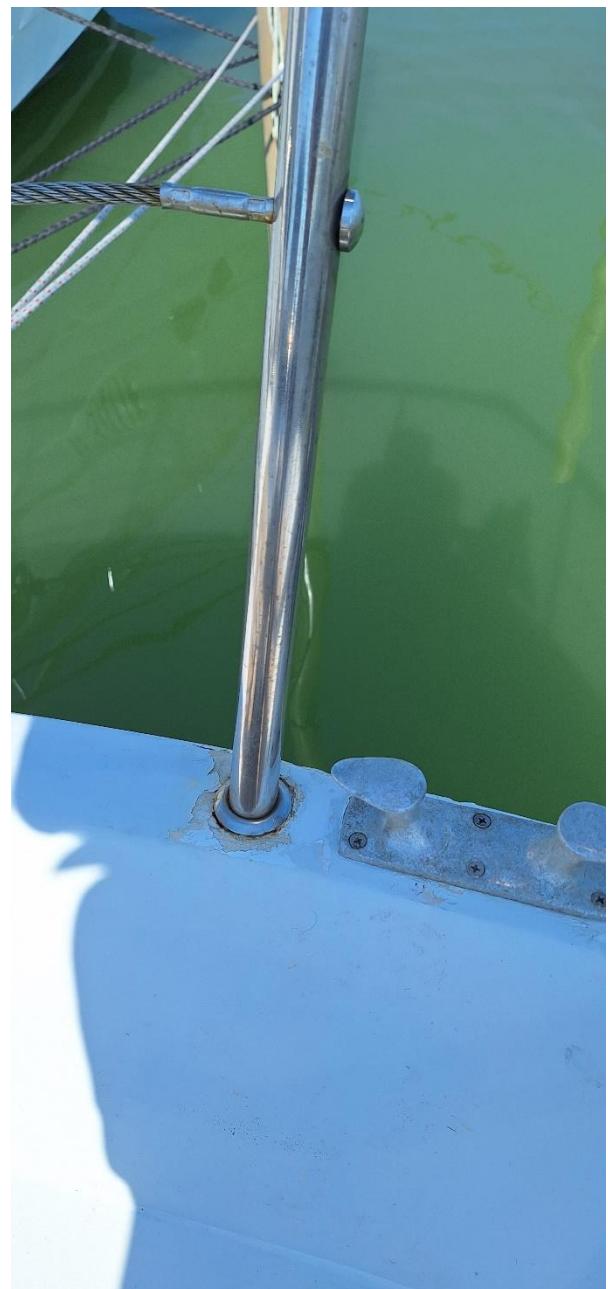
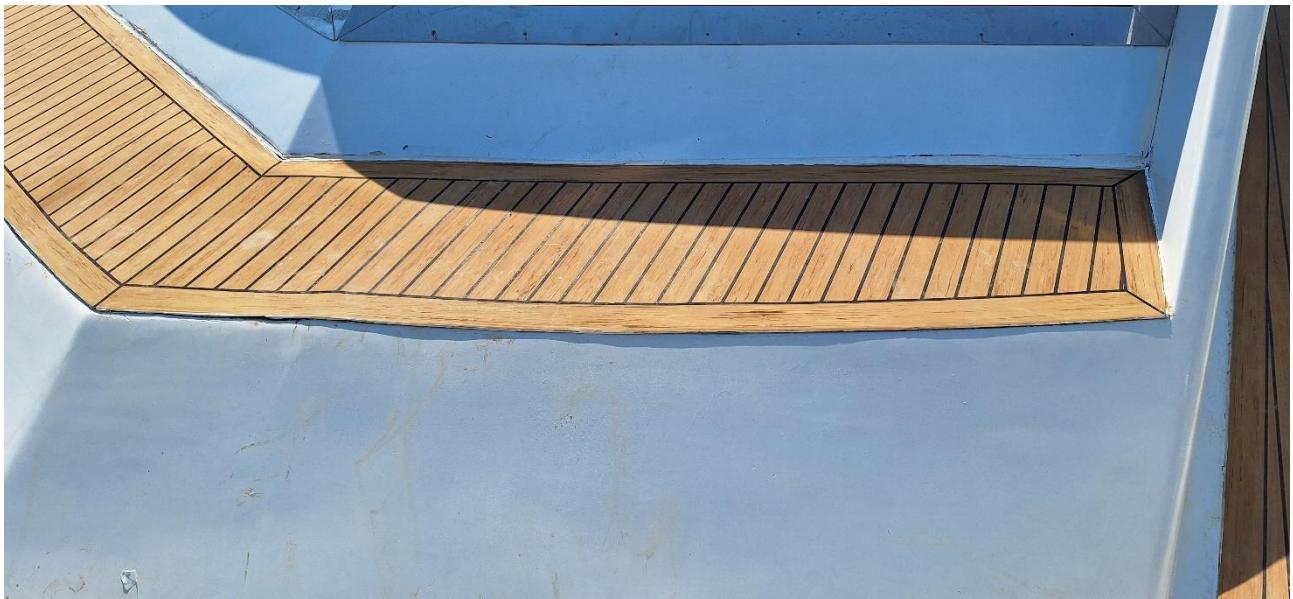
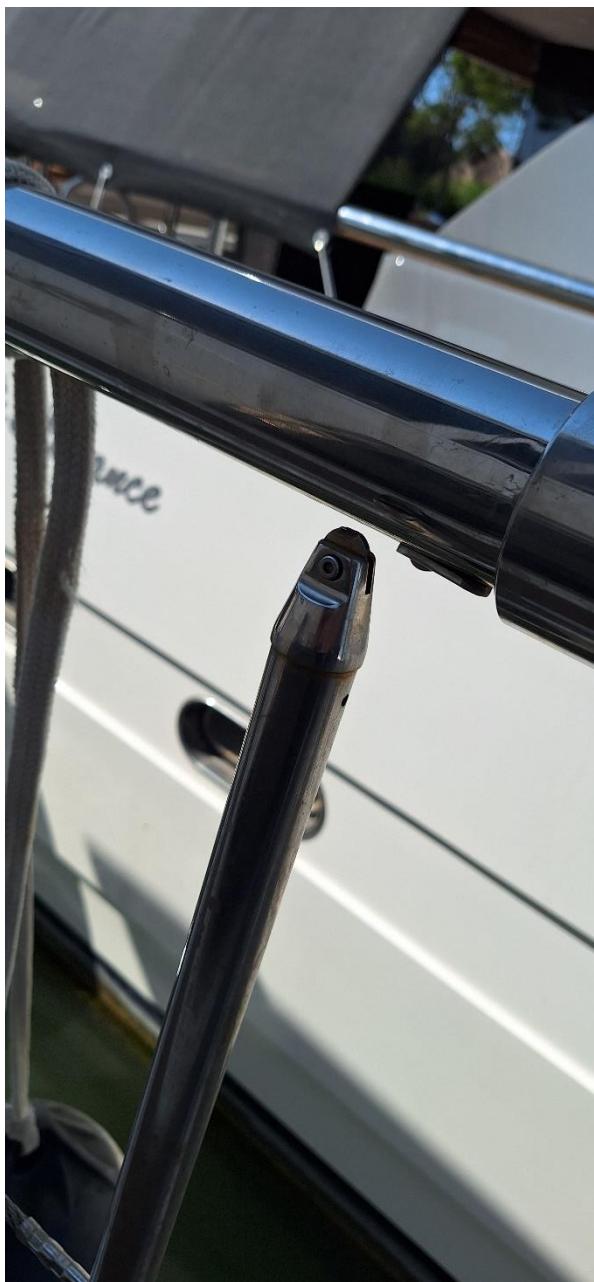
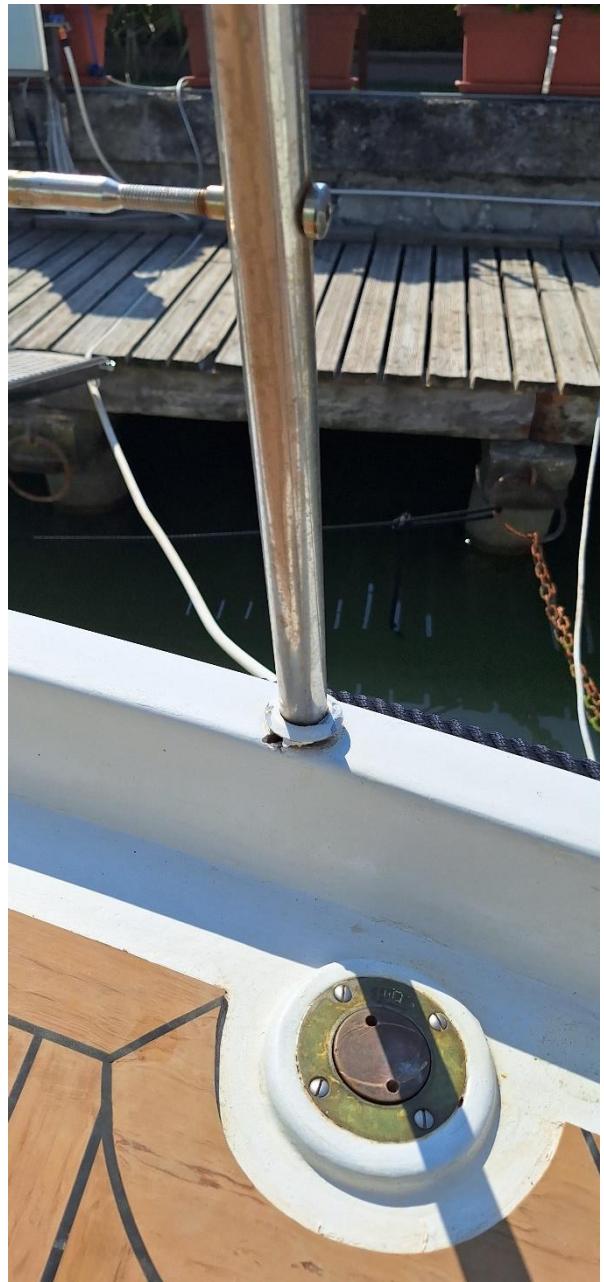
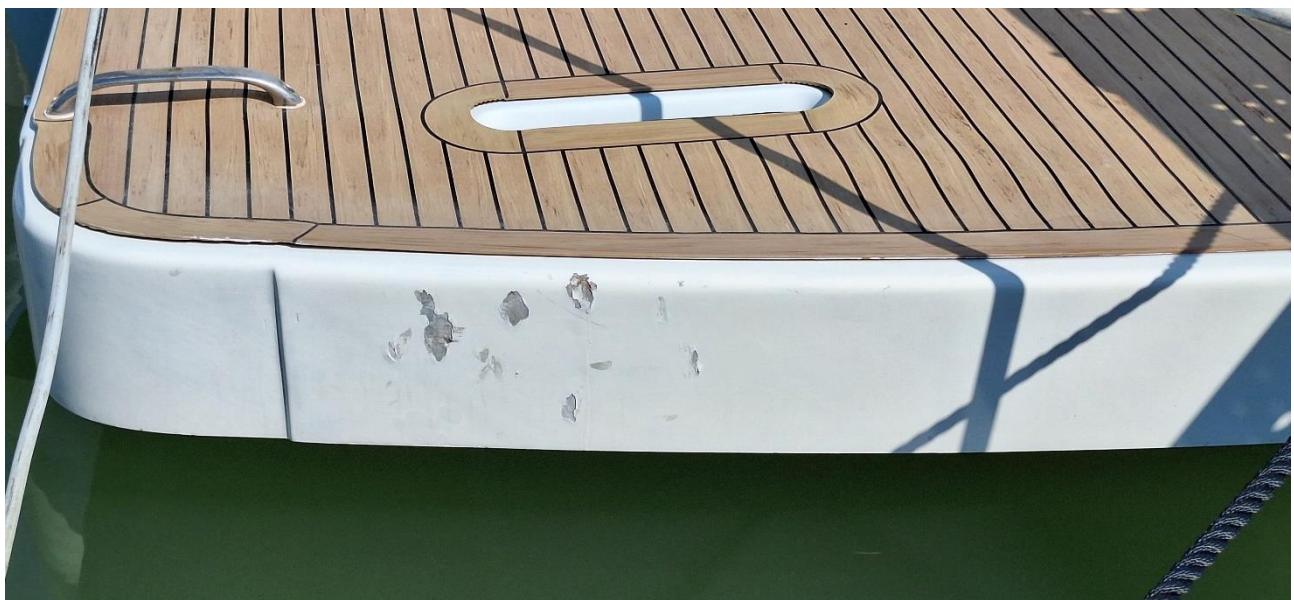
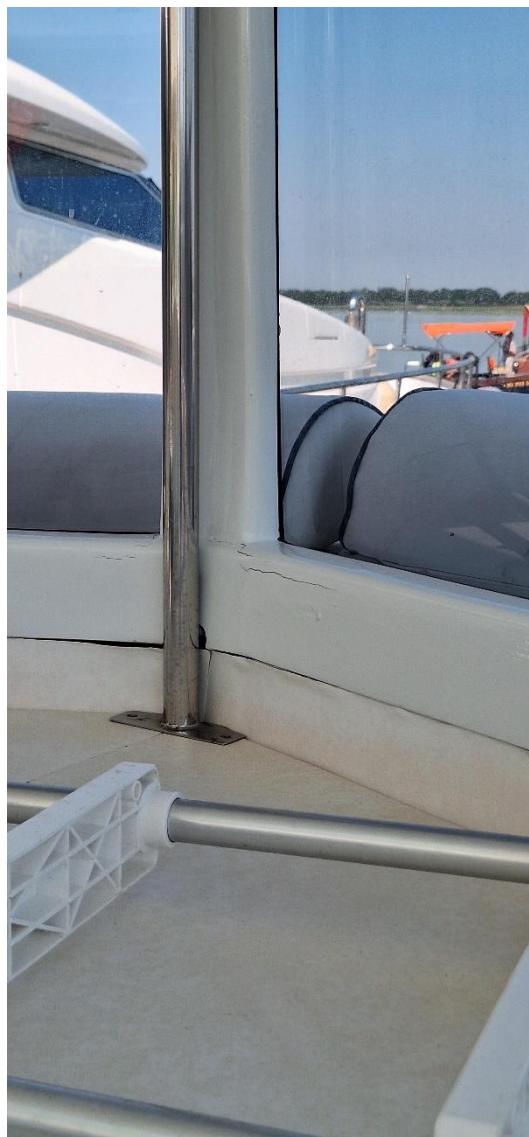
External inspection

Superstructure has been recently renewed but there are some fractures in the structural corners of the hard top, fiberglass is fine, synthetic teak has been installed, some parts are curved, some parts are detached from the below surface, the handrail is not properly fixed to the deck and this causes water leaks to the below area of the hull. The front window is not properly sealed and this also causes water leaks in the front cabin.

Would be recommended to remove all the teak to check the conditions of the deck and make a proper installation. The rail should be tightened and sealed as the windows to remove all the leaks. It was not possible to check the hull because boat was in water but it's highly recommended to pull the boat out of the water, let it dry for a few weeks and make a deep check of humidity to prevent and be sure that no osmosis or delaminations of the hull are present.

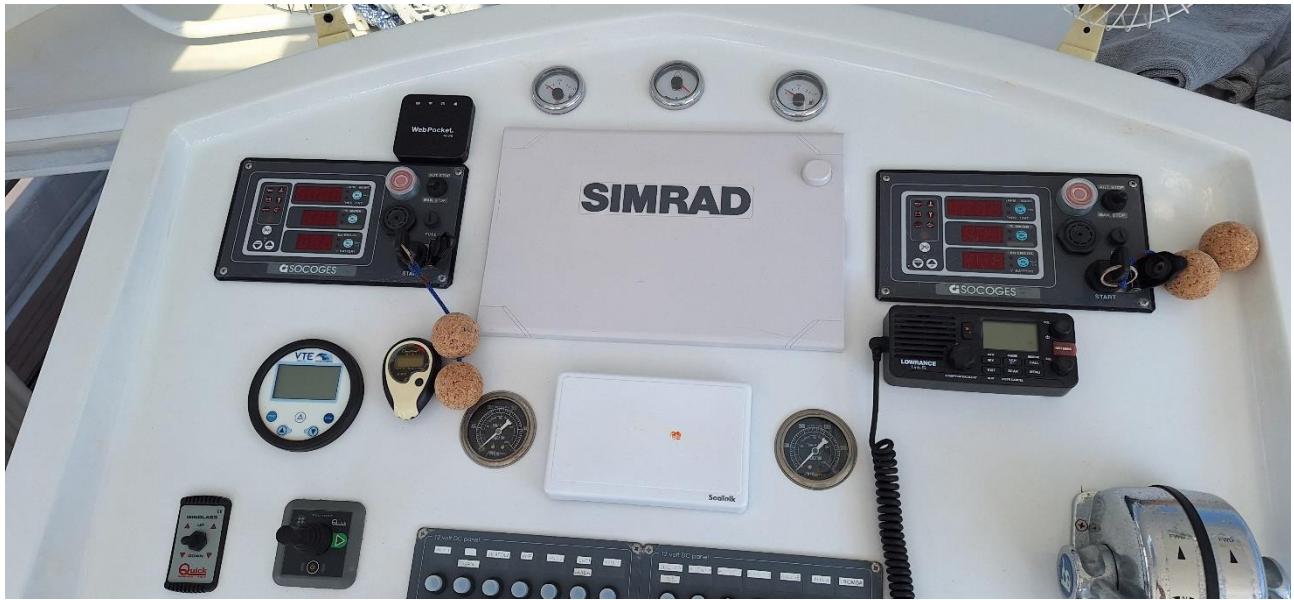
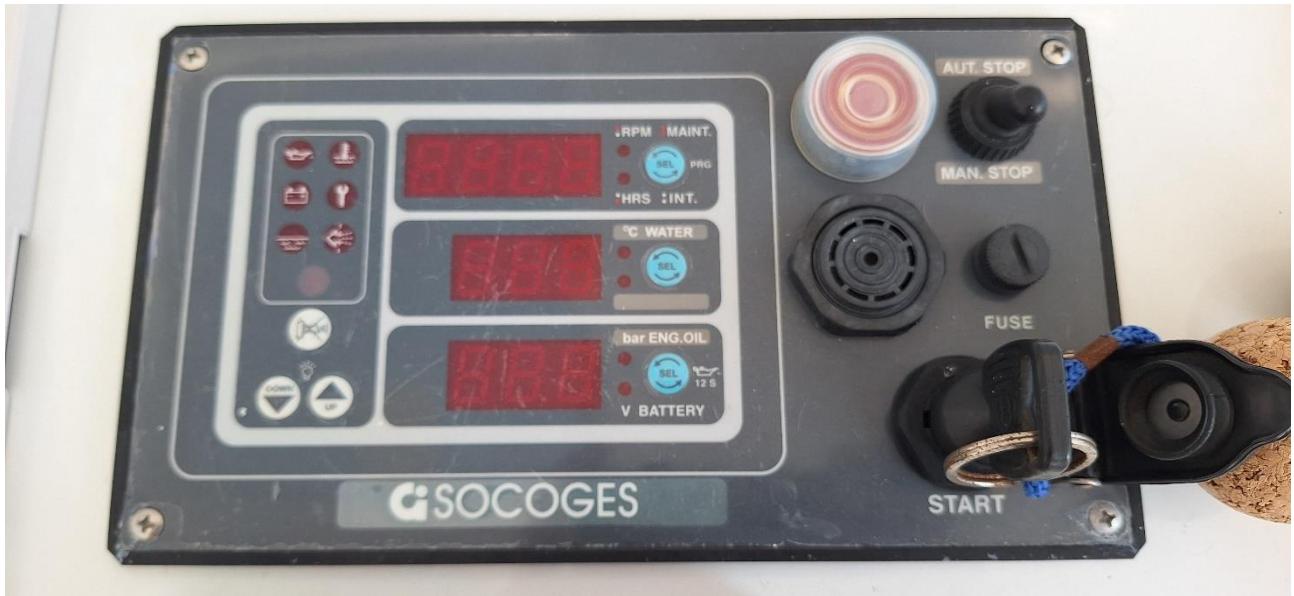
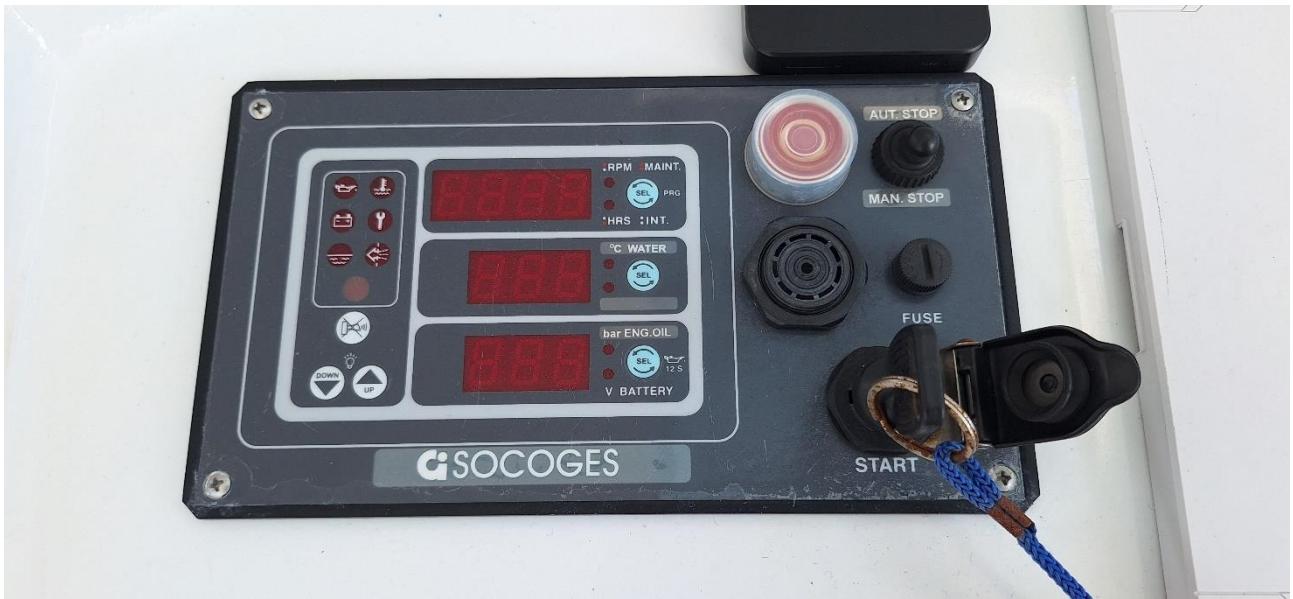
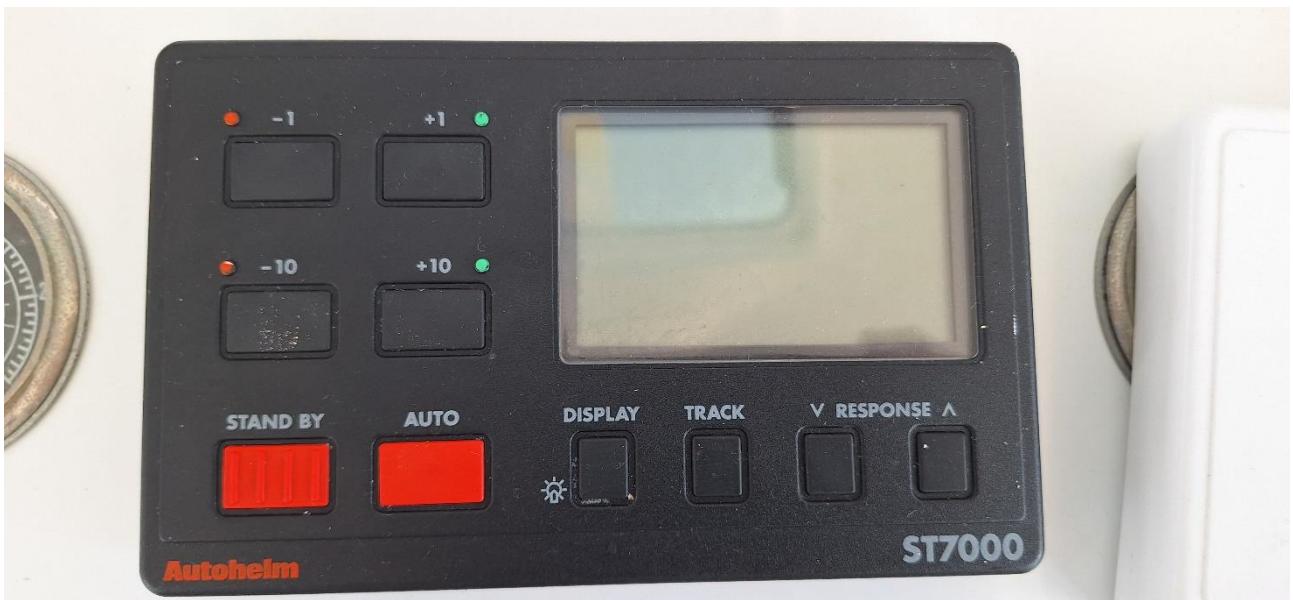
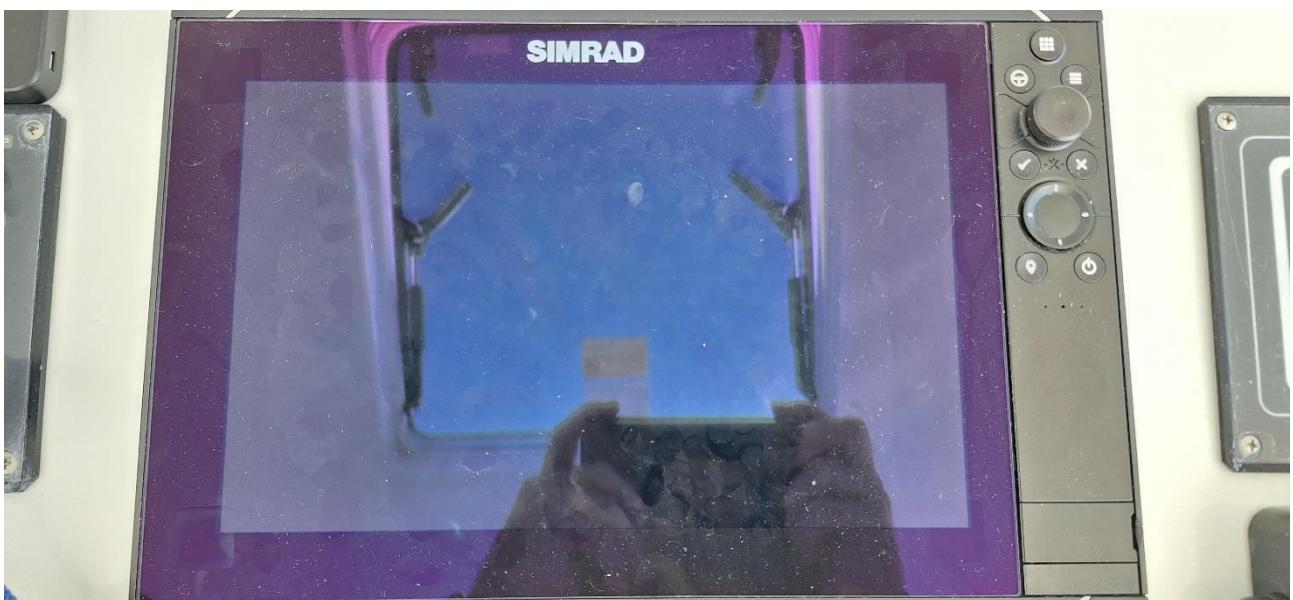
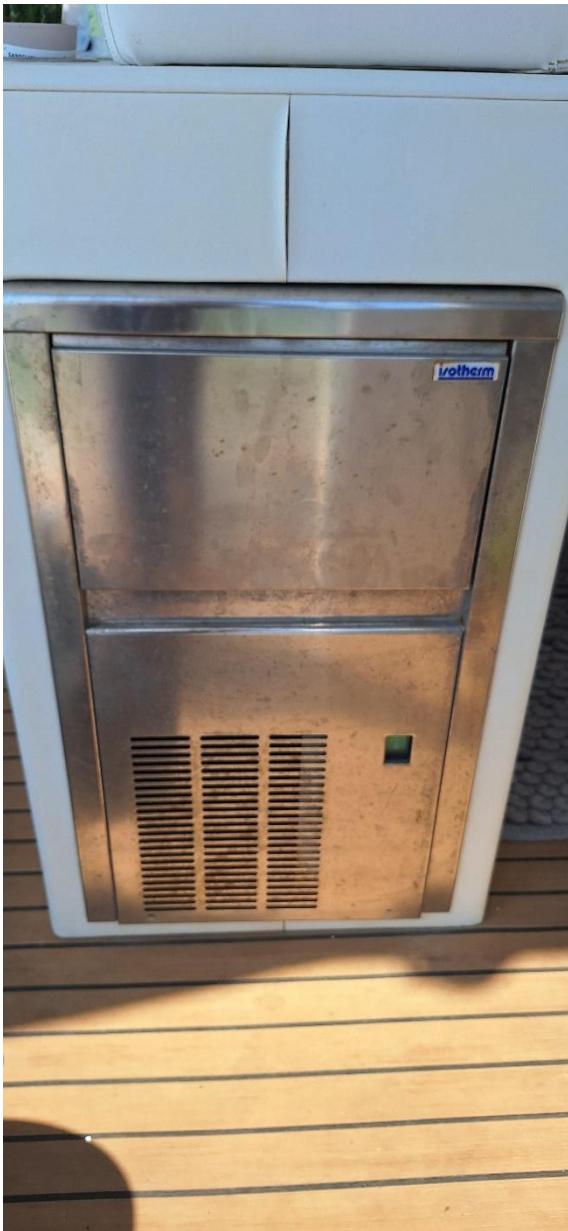
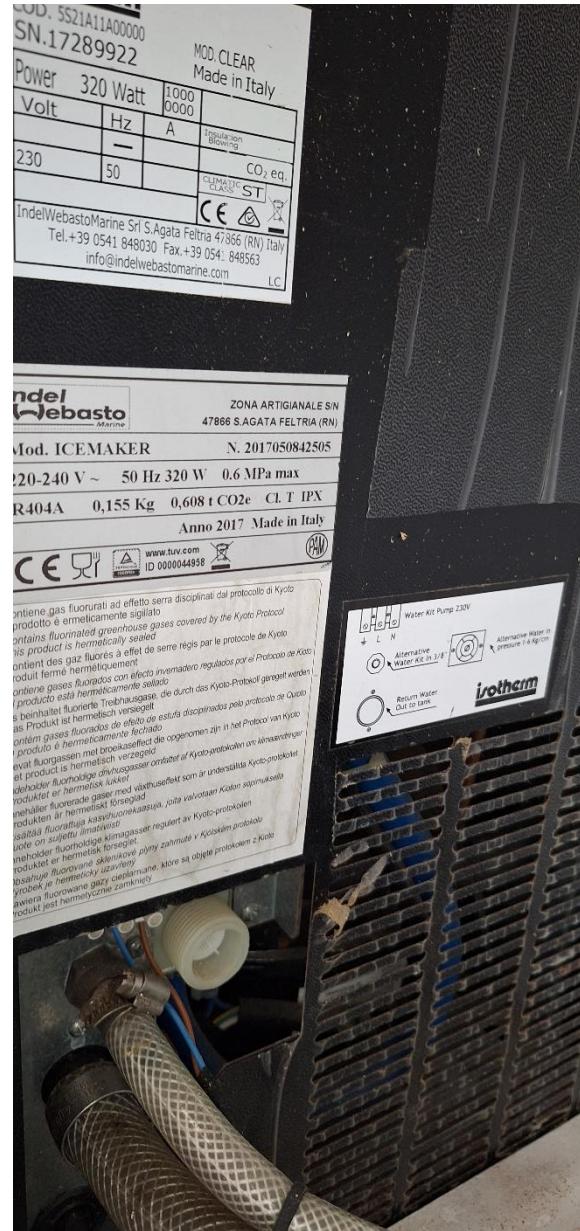
DECKHOUSE

All the instruments are working properly; port/starboard engine panels are fine, VHF is fine, generator panel, bow thruster, autopilot, winch anchor, icemaker are ok.

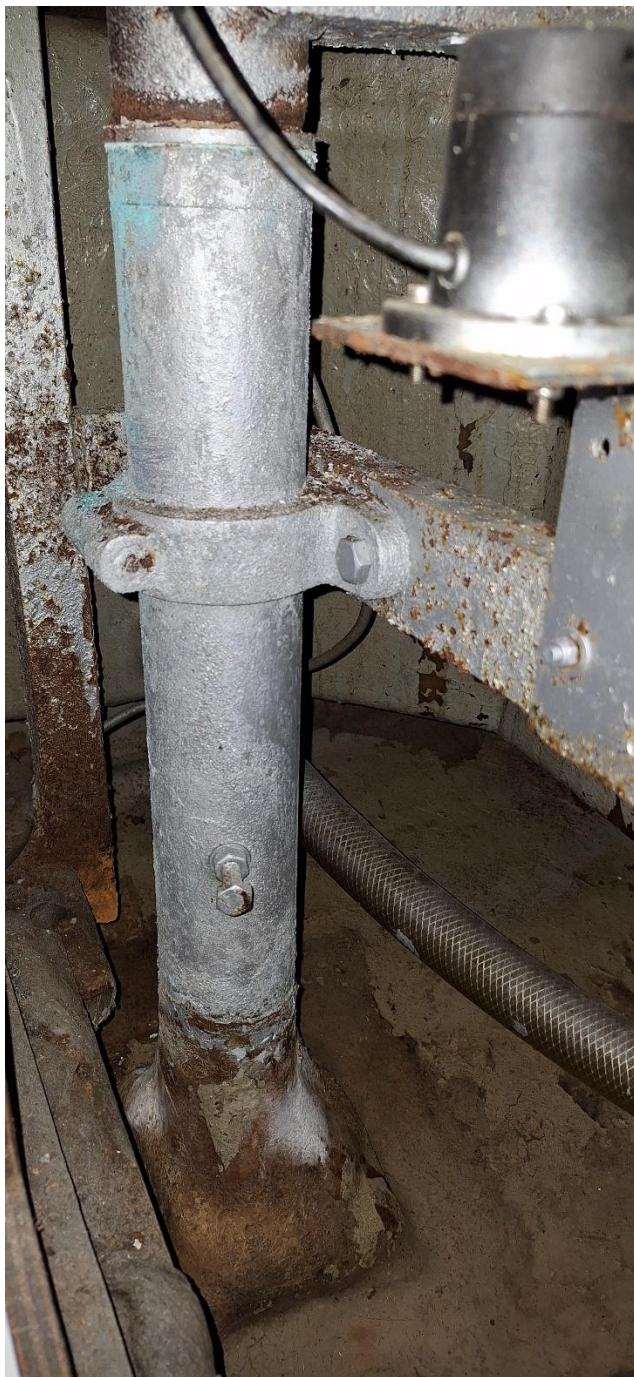
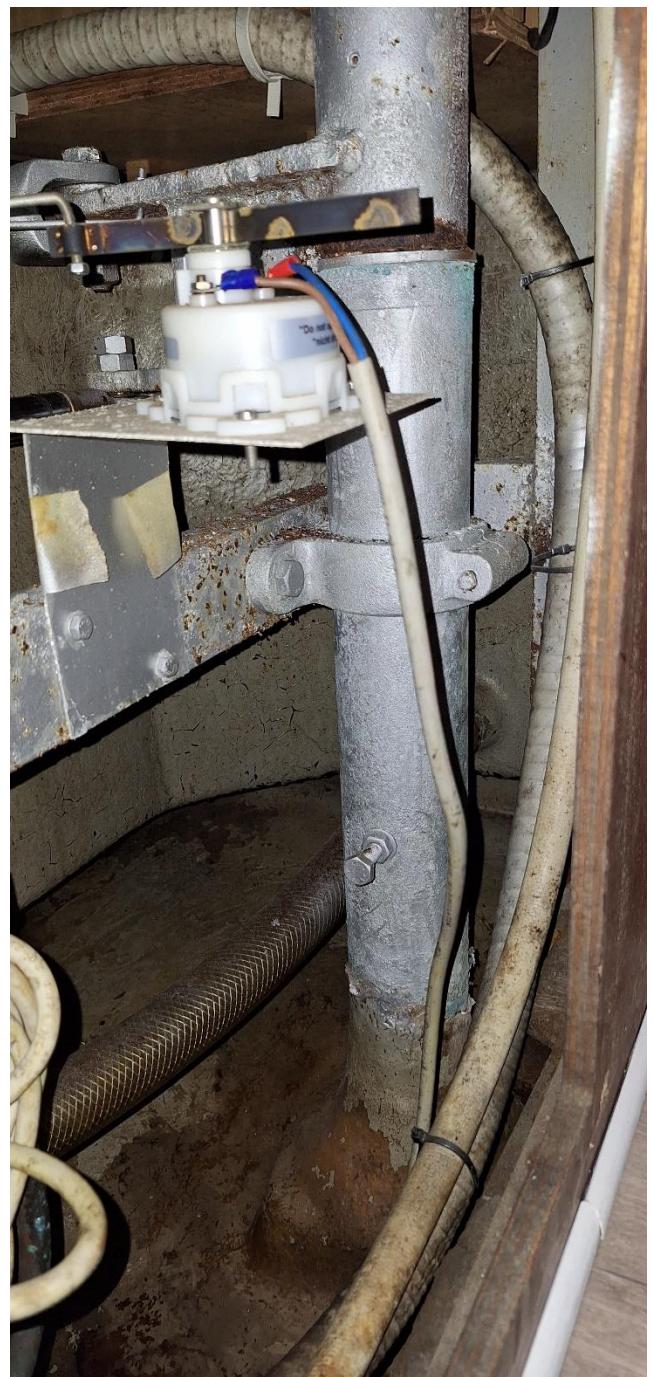
WHEELHOUSE

This area is in quite good conditions compared to the age of the boat but a strong maintenance will be necessary even if there's no water leakage.

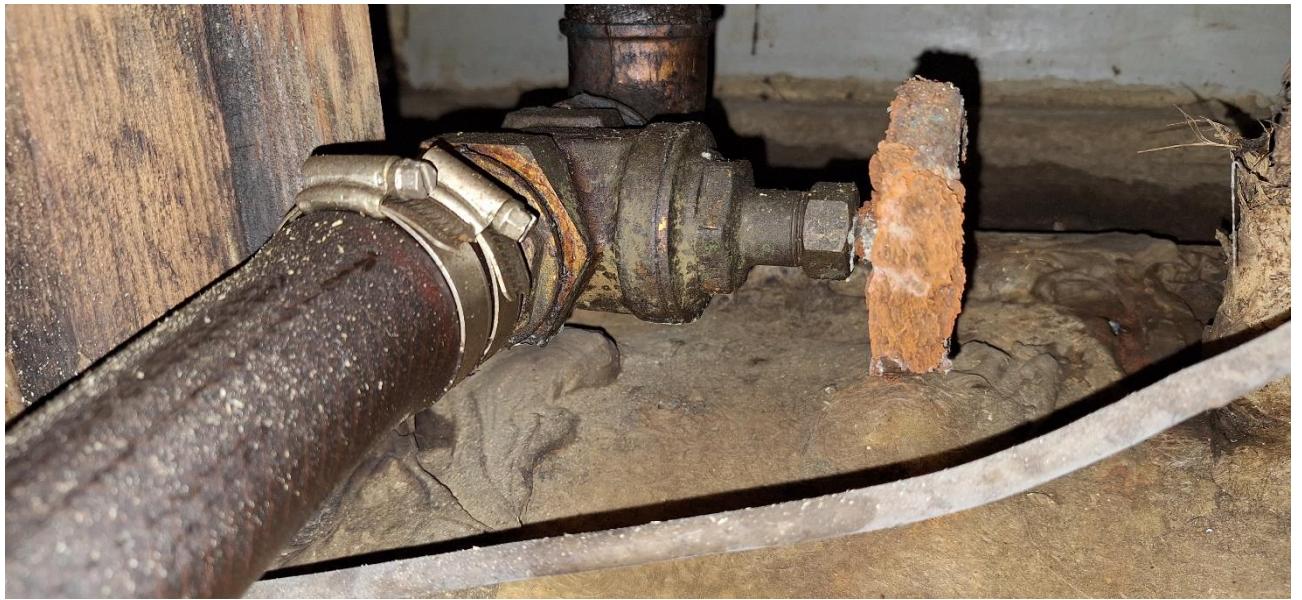
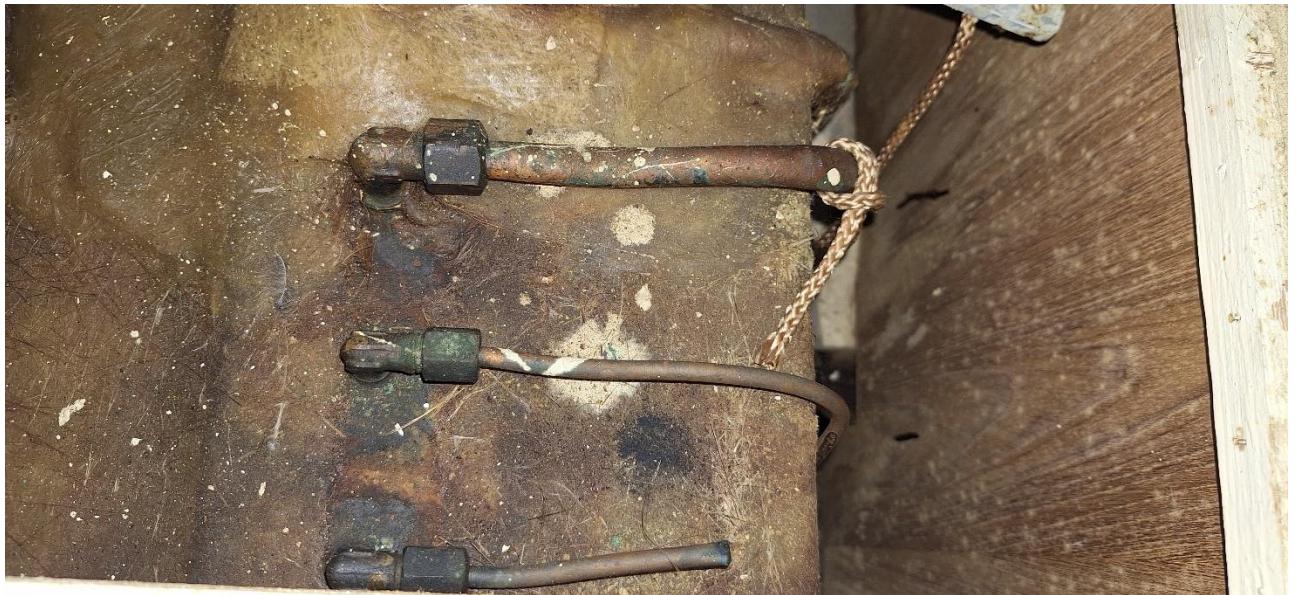
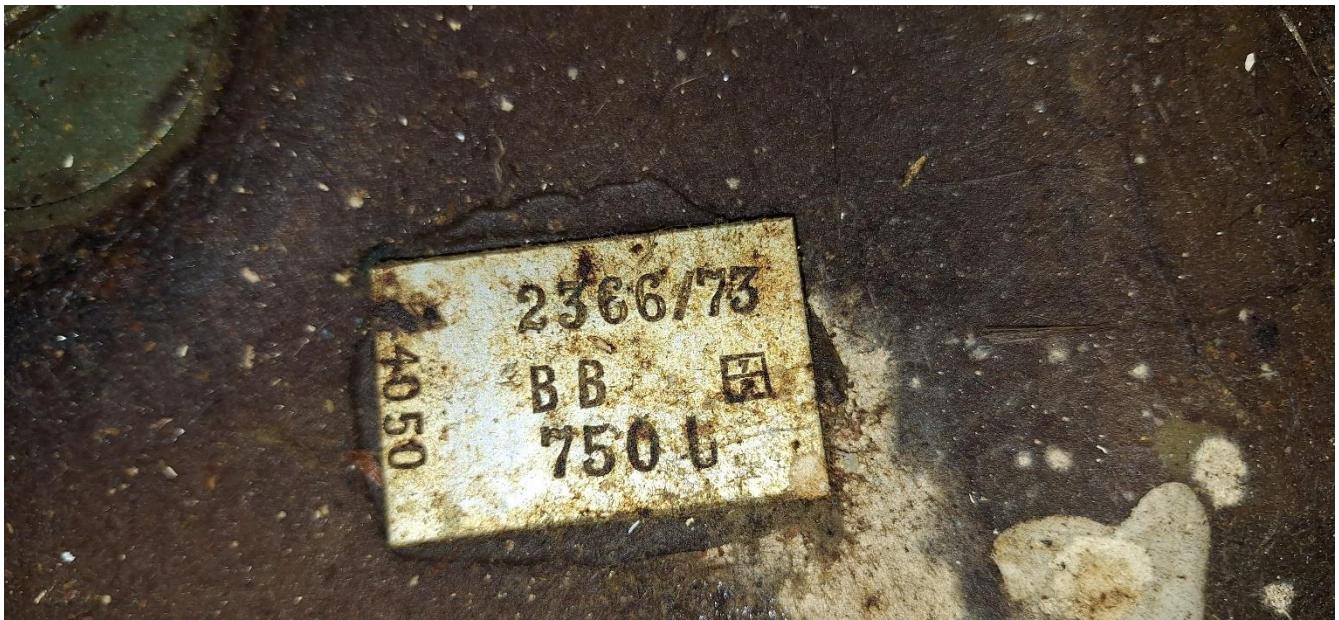
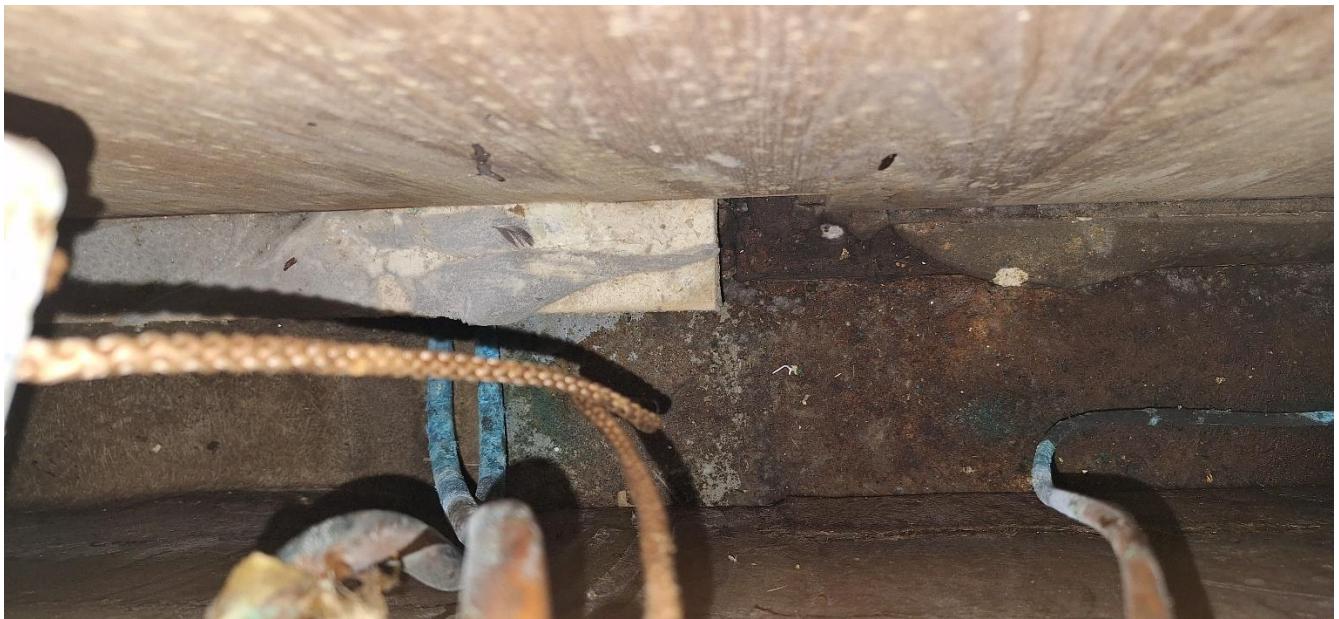
AFT CABIN

Below the two beds there are the diesel tanks. There are no leaks but the owner should consider the option to replace them with more new INOX tanks in near future. The valve seems to be blocked.

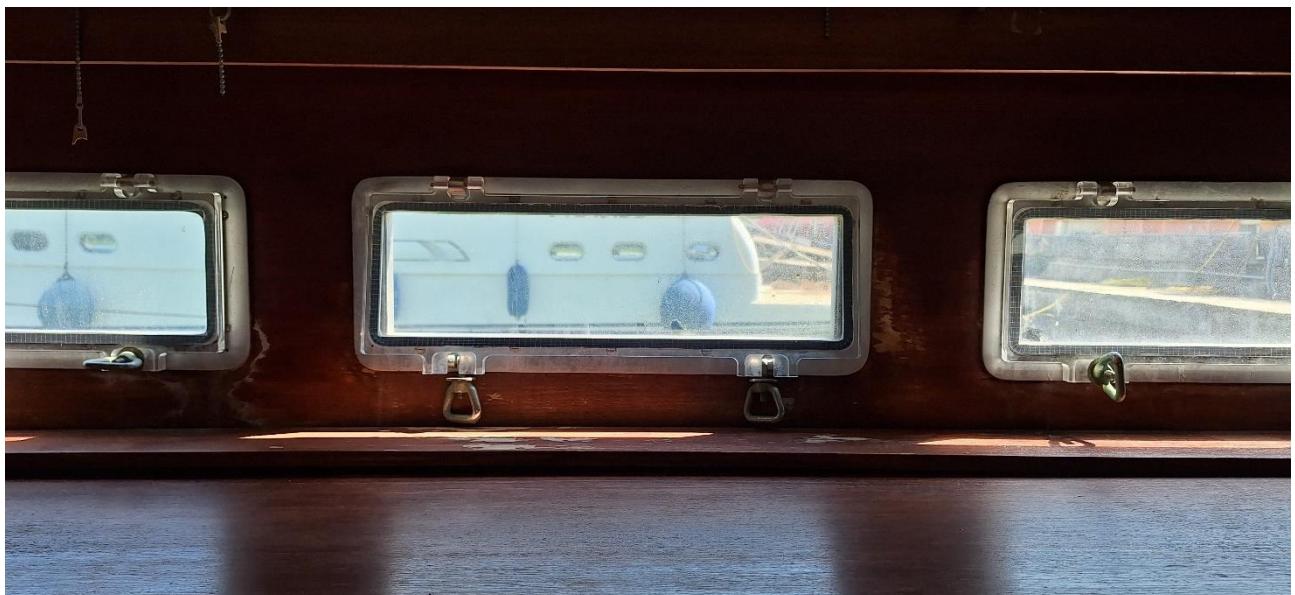
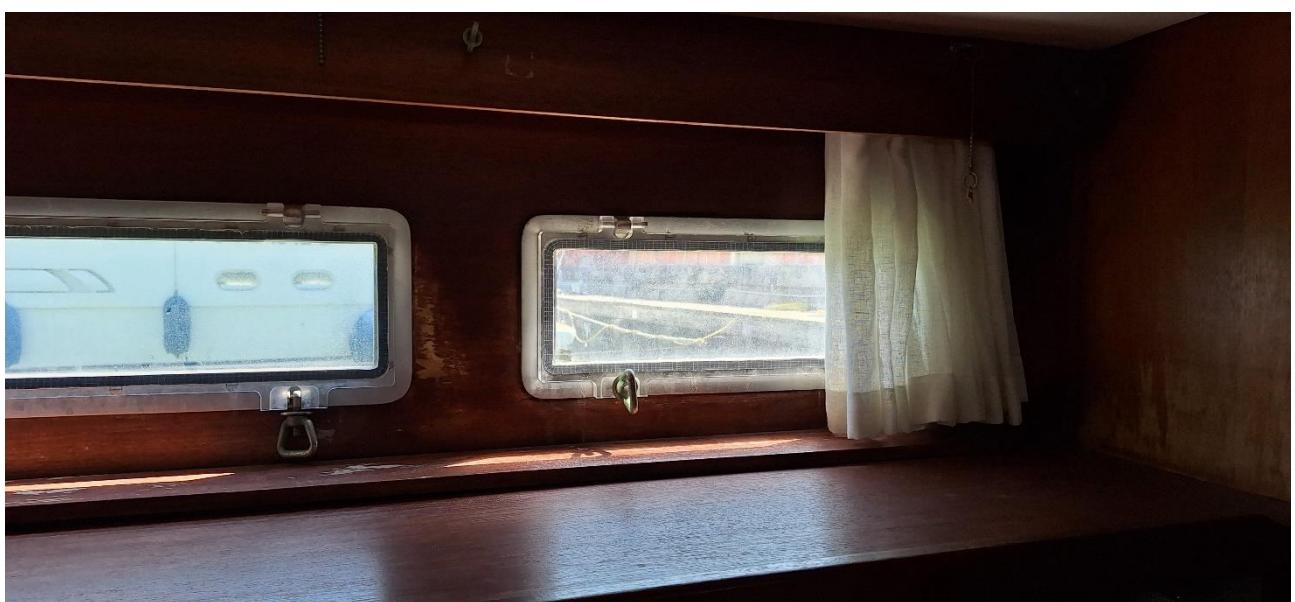
Internal overview

All the wood construction appears in good shape considering the age of the boat; there is evidence of leakage from almost all the windows and from the upper deck that should be checked and solved. Lights, water pump, toilet pumps are working properly.

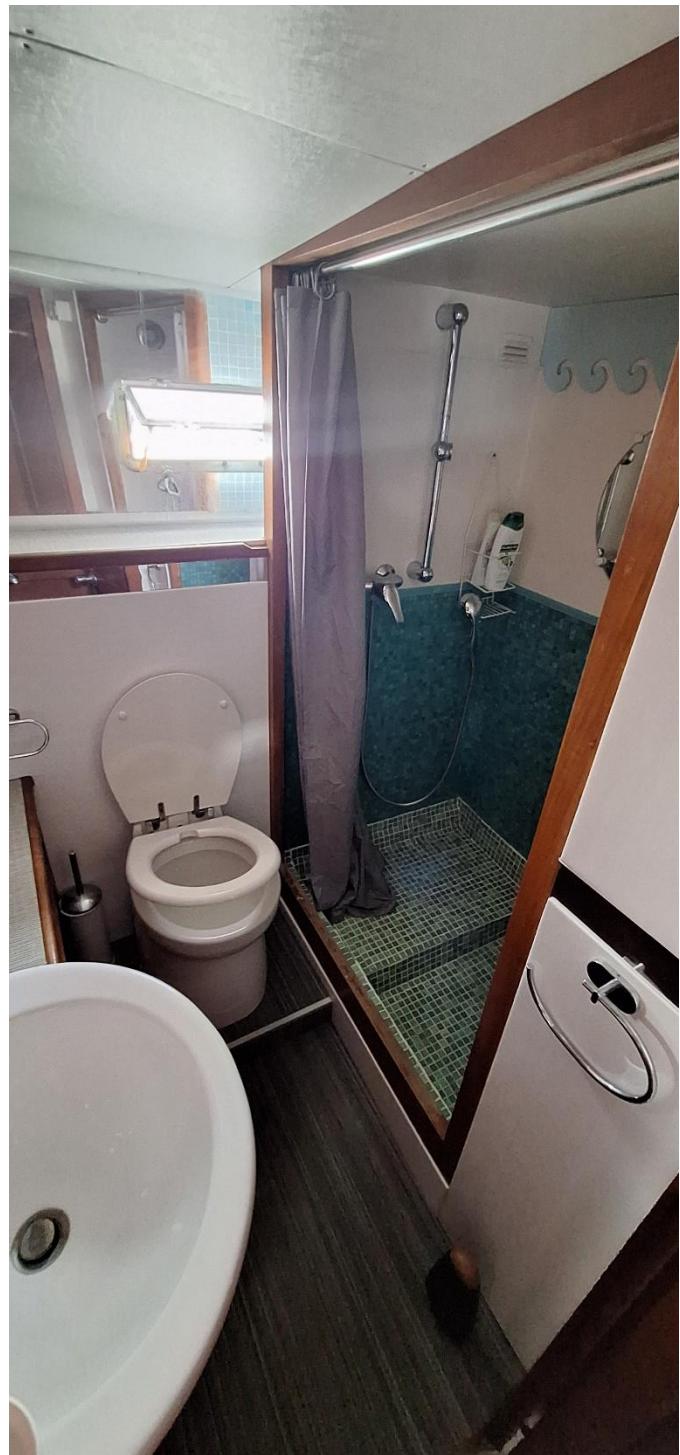
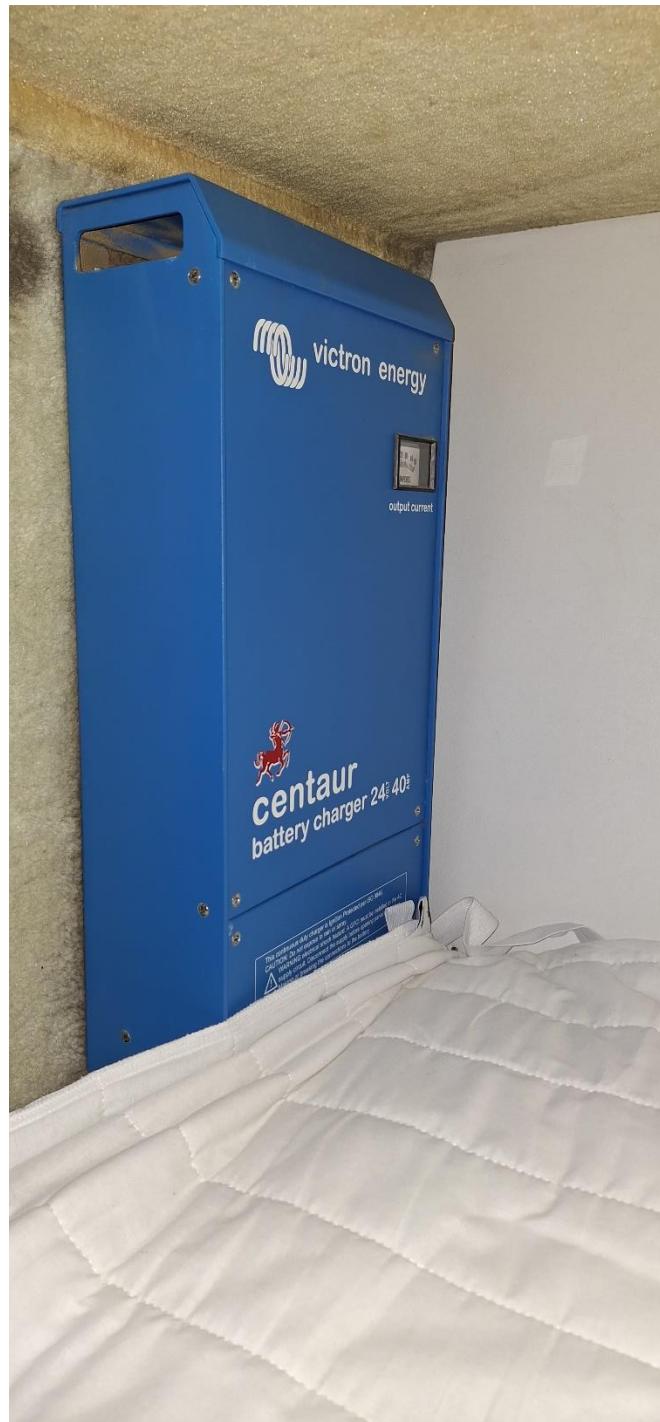
The battery system should be reconsidered. The batteries are in a closed space with no ventilation, would be recommended to open some holes for air circulation. The position of the battery charger should be changed too, it's close to the bed.
