Survey report m/y "La Calypso"

Bibione – Porto Baseleghe 16/07/2024

Builder Ancora Yachts – Model 44

Registration number 921774 UK

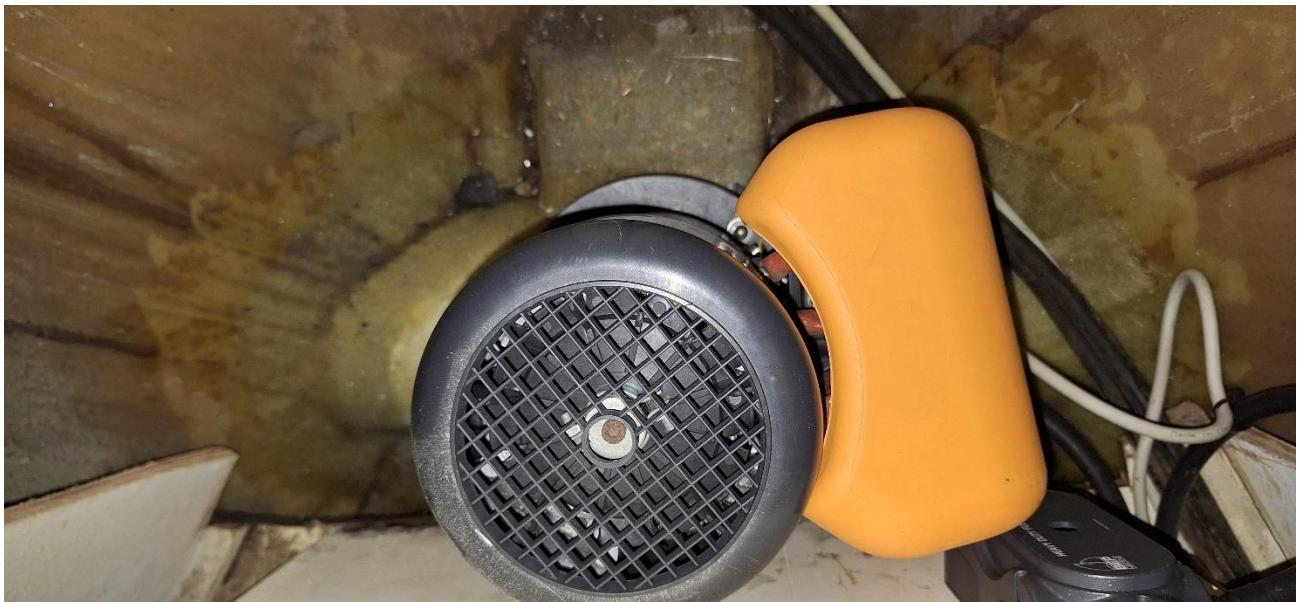
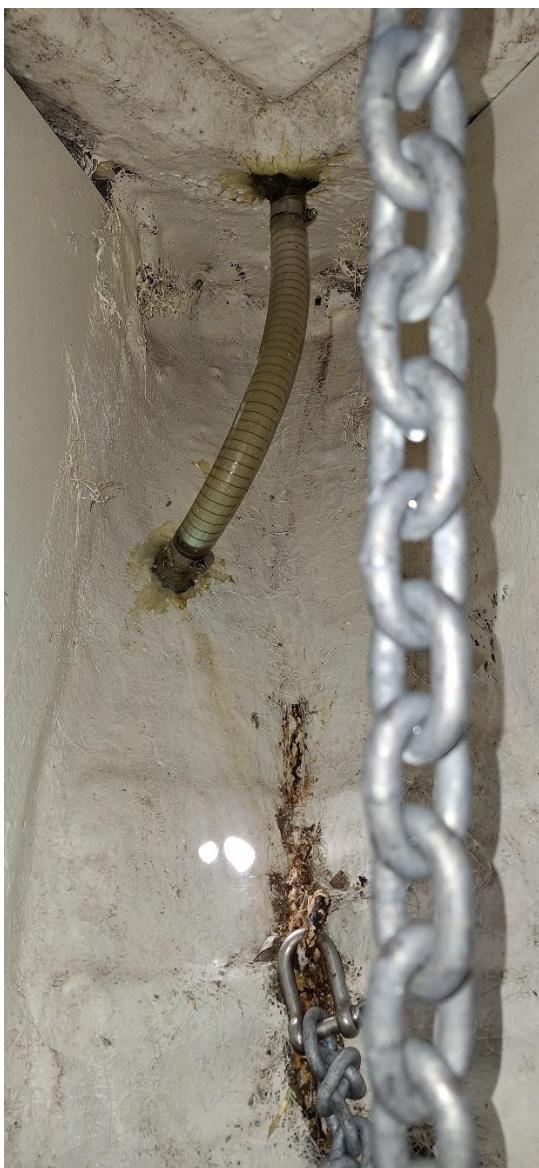
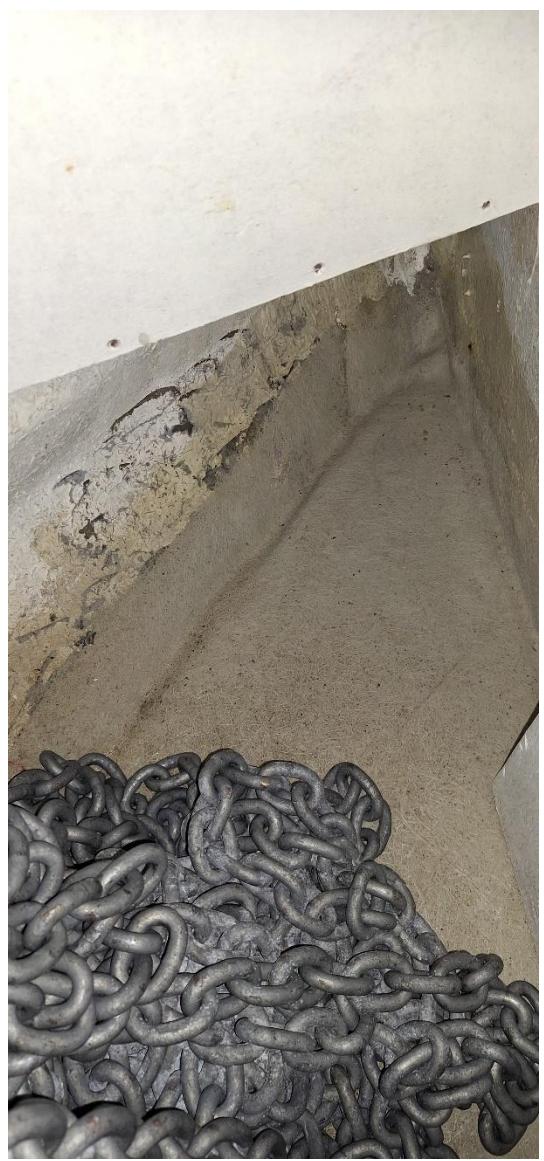
Bow thruster tunnel is also fine with no stress signals at all. Same for anchor winch (behind the front cabin mirror) and chain.

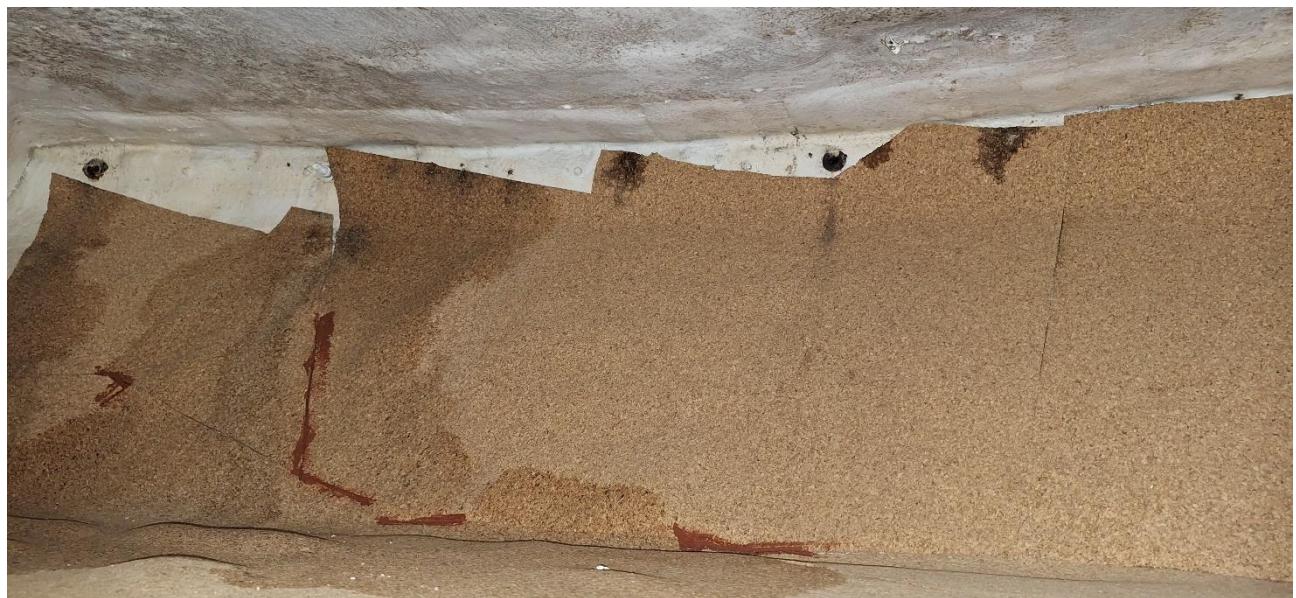
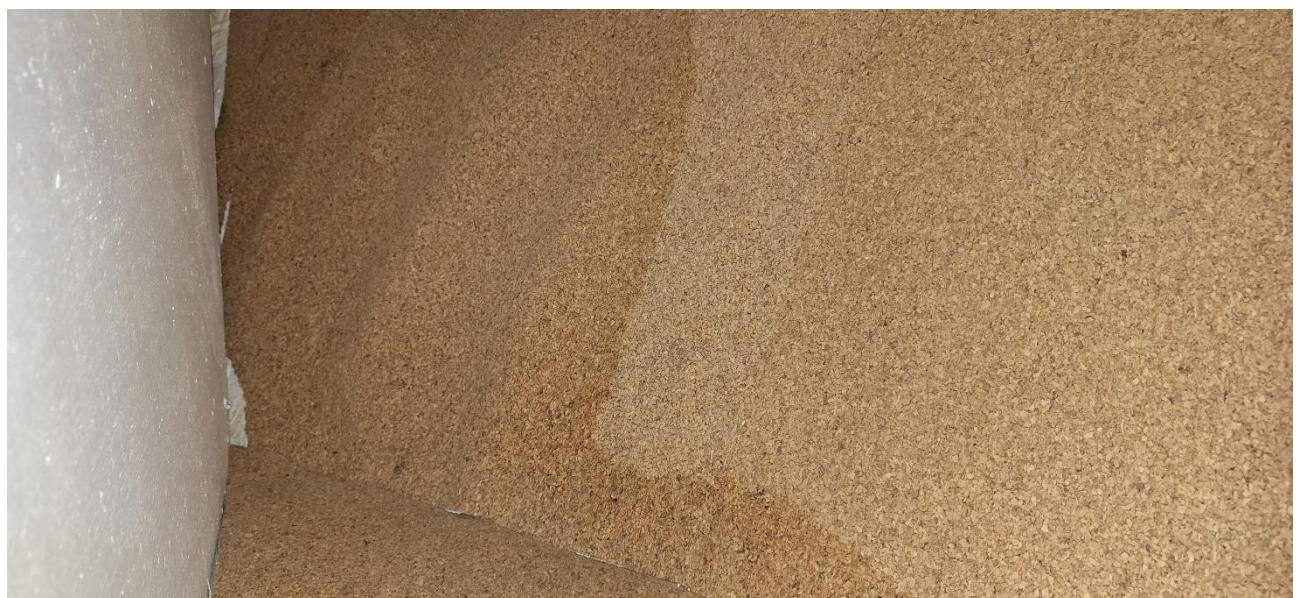
In the front area there are signs of leaking in the cork on both sides that must be fixed to prevent mold.

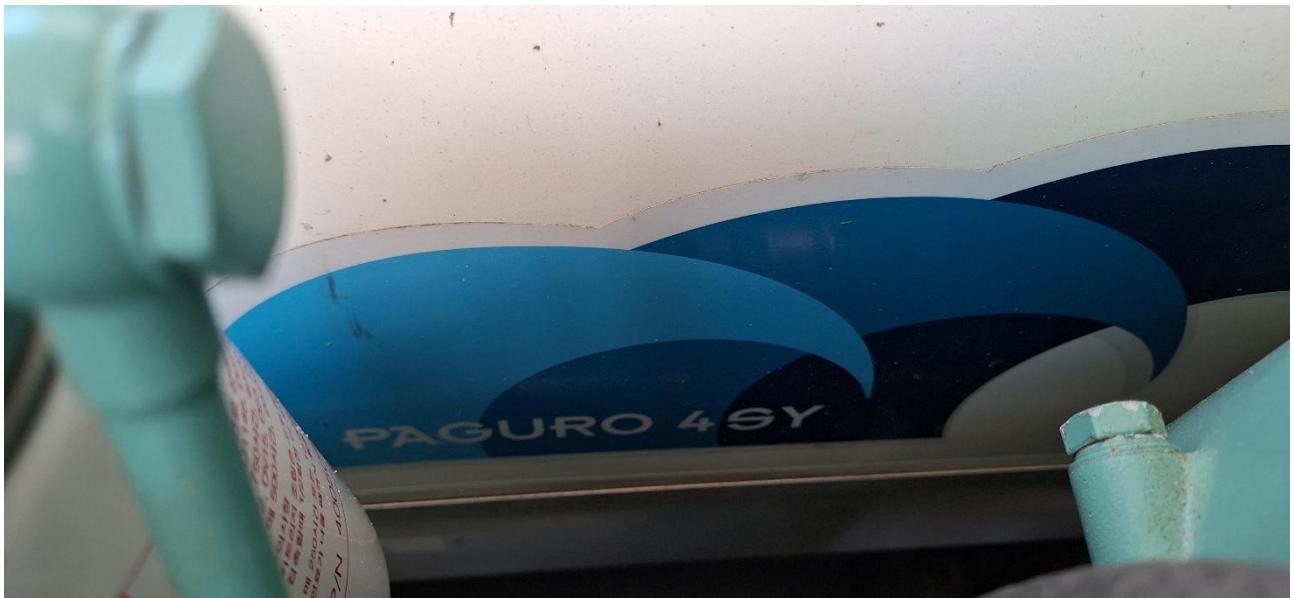
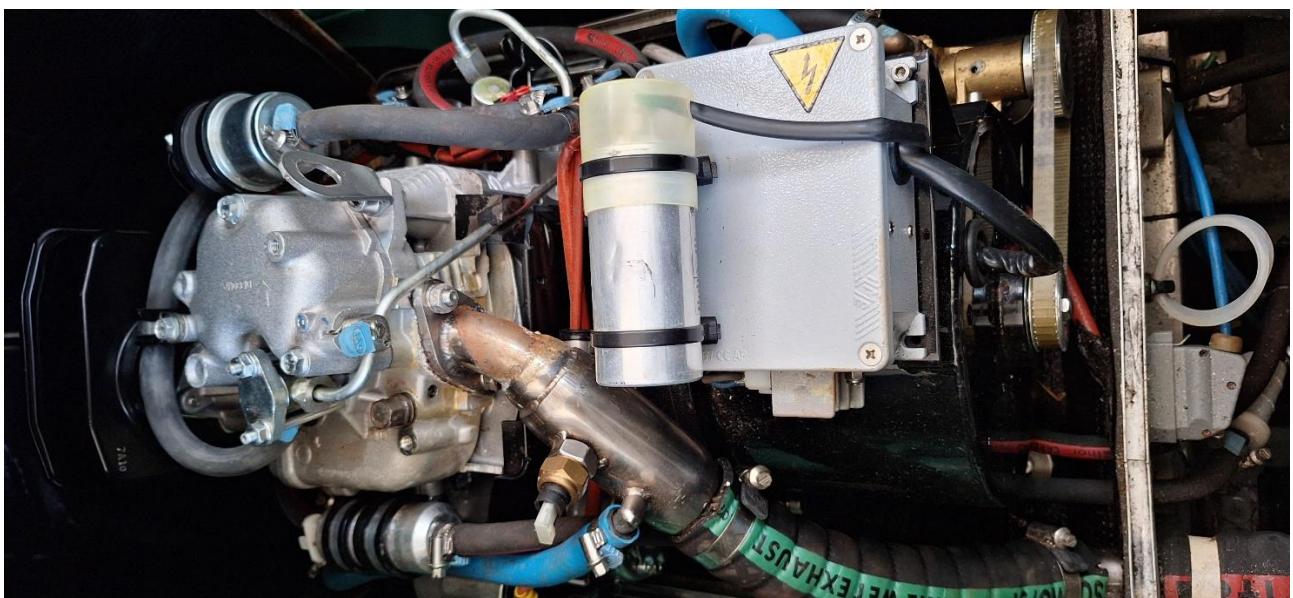
Generator Paguro 4SY is well maintained and working properly.
